# GO TO THE SOURCE

SOURCE ENGINEERING'S  
TRAILING ARM KIT  
FOR ROADMASTER  
R4R AND R4RR CHASSIS  
SOLVES A CRITICAL  
SAFETY ISSUE

by CHRIS HEMER

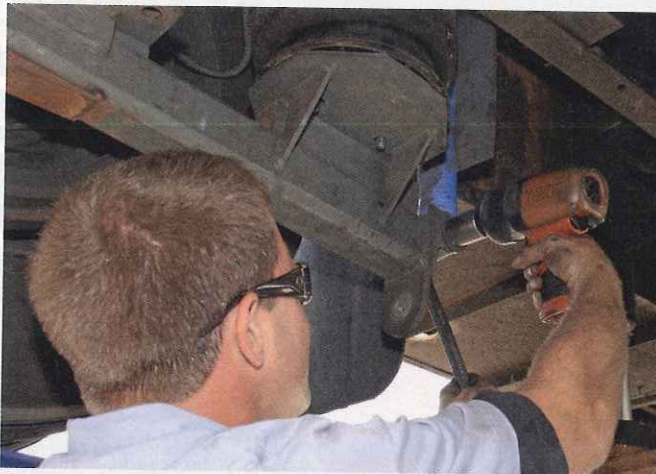
3. The lower shock mount bolt is loosened, but before it is removed, the rear of the trailing arm is supported to prevent it from falling down.

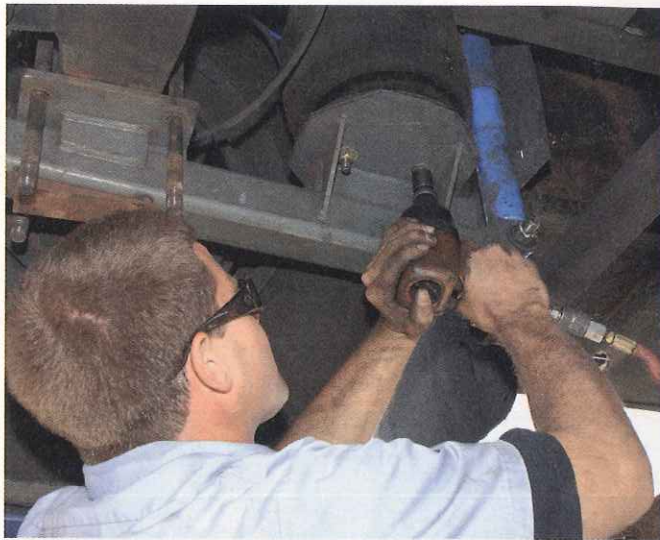
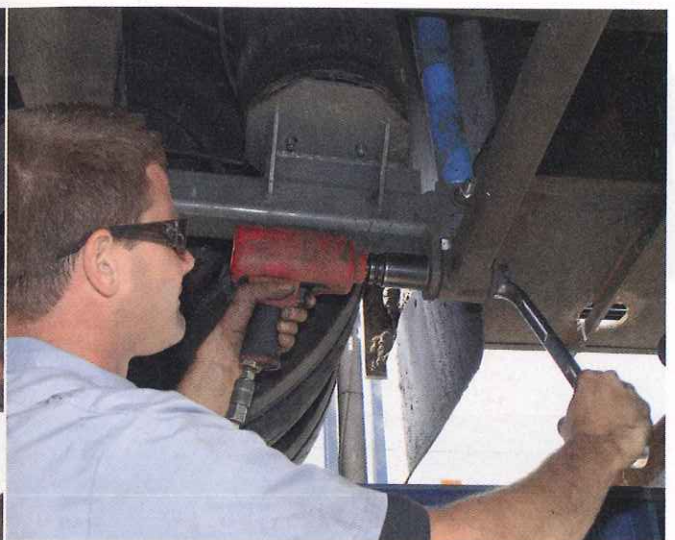
2. Once the air has been released from the air bags, the first step is to remove the nuts from the  $\frac{3}{4}$ -inch U-bolts that secure the arms to the rear axle. Next, the nuts that secure the air bag to its perch are removed, followed by the rear track bar mounting bolts.

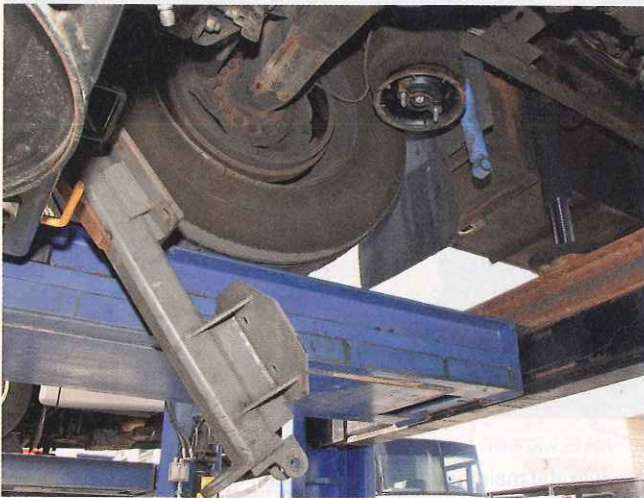
4. With the shock removed, the arm can hang freely.

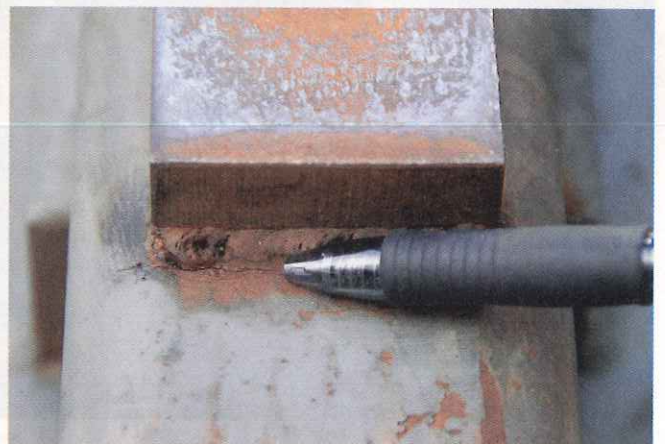
5. A crack begins to form at the weld. Once a crack starts, the arm can fail completely (and without warning) within 3,000 to 4,000 miles.

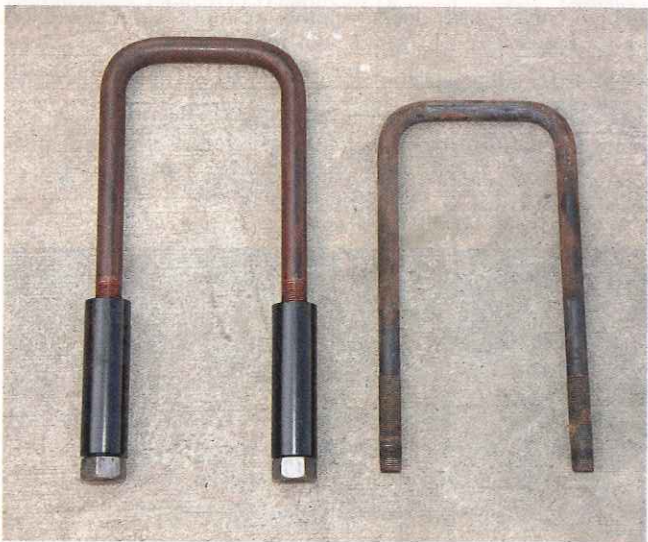
7. The TRA-1003 kit comes with new  $\frac{7}{8}$ -inch U-bolts, which are far more robust than the stock  $\frac{3}{4}$ -inch bolts.

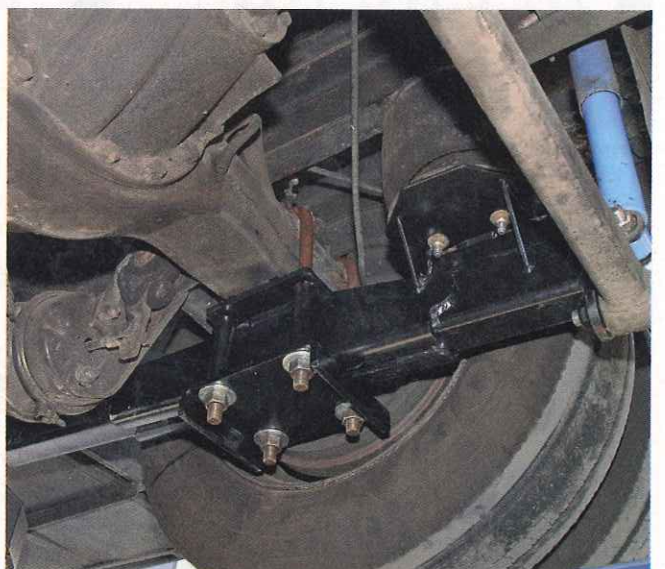
8. The new bar is installed, ready for years of trouble-free travel.
